**Flood Control Project Maintenance
Levee Inspections**
LMA District Cover Sheet
Spring 2019 Levee Inspection Results

Levee District No. 0001 (Sutter County)

Spring 2019 Levee Inspection Results

Waterway			Bank	Unit Miles
Unit No. 01 Feather River			Right	16.11
	Spring (March - May)	Summer (June - August)	(September - November) Fall	Winter (December - February)
Unit Maintenance Rating (Fall Only)				
Date of Inspection	4/12/2019 - 4/12/2019			
DWR Inspector	Sterling York			
Accompanied By	Andrew Stresser LD0001S

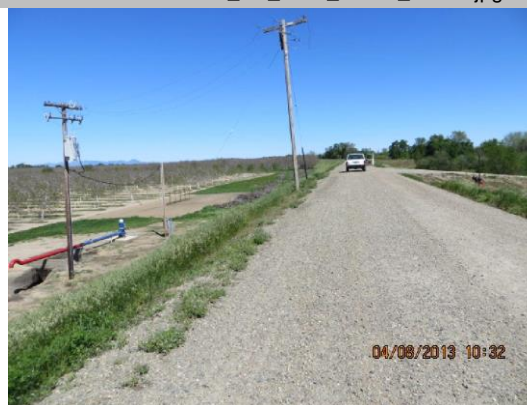
Photo 1 of 3 : UCIP_SP_2019_41624_18769.jpg

Comment Code						
Inspector Comment						
FS_ID:41624 DS_ID:18653 EP_NO: 4667 Repair Type: Non-Urgent Crossing Status: Found UCIP Comments: 04/12/2013 Abandoned crossing. Concrete box on both sides found. Pipe remainings are found on WS. (DWR UCIP - P. Amatya) FIELD_STRUCT_DESC: *ABANDONED* 36-inch steel irrigation pipe through the levee, 10 feet below the crown. Concrete box found on each side. Pipe remains found on the waterside (WS) after the removal of 40 feet of 36-inch steel pipe from a spur levee and 20 feet of 36-inch steel pipe from the landside (LS) slope of the Feather River Levee. (Plans for removal of a portion and filling with concrete a portion of an abandoned 36-inch steel pipe through the levee authorized under Permit No. 4667, 1964 - Levee District No. 1 of Sutter County [LD0001S]). [Additional Reference(s): USACE Sacramento O&M Manual 144, August 1955, (Station 735+57)]. FS Date: 4/12/2013

Crown view- overview of both sides of the levee

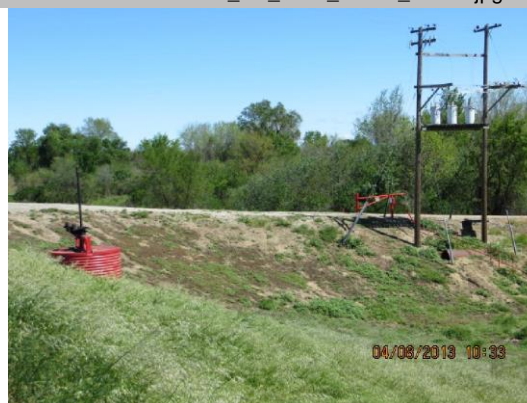
Photo 2 of 3 : UCIP_SP_2019_41624_18768.jpg

Comment Code						
Inspector Comment						
FS_ID:41624 DS_ID:18653 EP_NO: 4667 Repair Type: Non-Urgent Crossing Status: Found UCIP Comments: 04/12/2013 Abandoned crossing. Concrete box on both sides found. Pipe remainings are found on WS. (DWR UCIP - P. Amatya) FIELD_STRUCT_DESC: *ABANDONED* 36-inch steel irrigation pipe through the levee, 10 feet below the crown. Concrete box found on each side. Pipe remains found on the waterside (WS) after the removal of 40 feet of 36-inch steel pipe from a spur levee and 20 feet of 36-inch steel pipe from the landside (LS) slope of the Feather River Levee. (Plans for removal of a portion and filling with concrete a portion of an abandoned 36-inch steel pipe through the levee authorized under Permit No. 4667, 1964 - Levee District No. 1 of Sutter County [LD0001S]). [Additional Reference(s): USACE Sacramento O&M Manual 144, August 1955, (Station 735+57)]. FS Date: 4/12/2013

WS- abandoned pipe near power pole (right)

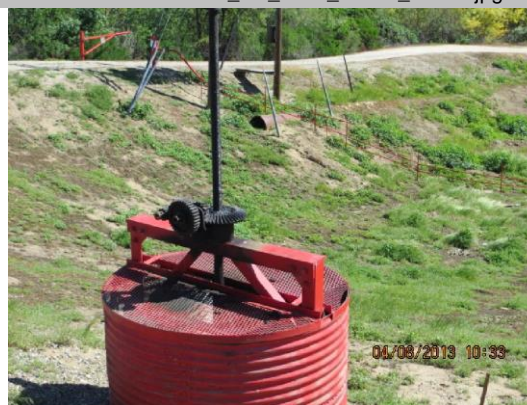
Photo 3 of 3 : UCIP_SP_2019_41624_18767.jpg

WS- abandoned pipe near power pole (top)

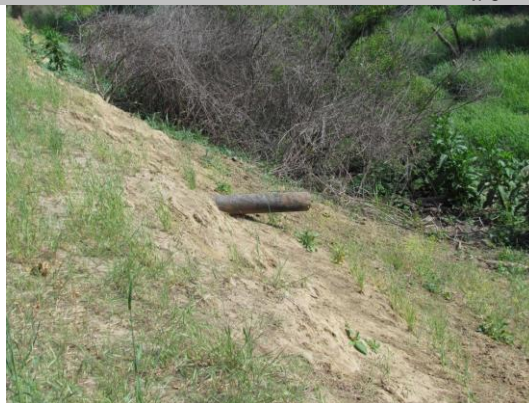
Photo 1 of 3 : UCIP_SP_2019_53068_75107.jpg

FS_ID:53068
DS_ID:17917
EP_NO: N/A
Repair Type: Non-Urgent
Crossing Status: Not Found
UCIP Comments: 10/15/2018 Pipe not found. Pipe removed as part of the Project Area A Feather River West Levee Project. Contacted LMA to obtain as-built drawings showing the pipe removal through the levee. Crossing has been downgraded from Urgent to Non-Urgent, waiting to receive as-built drawings pertaining to levee improvement project for this section of the levee. (O. Magana - DWR UCIP)07/20/2016 Same as previous comment, although pipe is open on the waterside (WS) and capped on the LS. Note that this section of levee will likely be reconstructed as part of Project Area A of the Feather River West Levee Project (Star Bend to Sutter Bypass). (K. Fazel - UCIP)05/23/2016 Needs proper abandonment; pipe open on both ends (courtesy of Sterling York, DWR Inspector). (K. Fazel - UCIP) FIELD_STRUCT_DESC: *REMOVED* 8-inch steel pipe of an unknown purpose through the levee, 4.6 feet below the crown. Siphon breaker in a 24-inch corrugated metal pipe (CMP) riser on the landside (LS) shoulder, not found in 2016. [Additional Reference(s): DWR Levee Log, 2005. USACE Sacramento O&M Manual 144, August 1955, (Station 657+00), As-Built Drawing No. 4-4-205-1].

Pipe visible on WS slope. Photo courtesy of Sterling York, DWR Inspector.

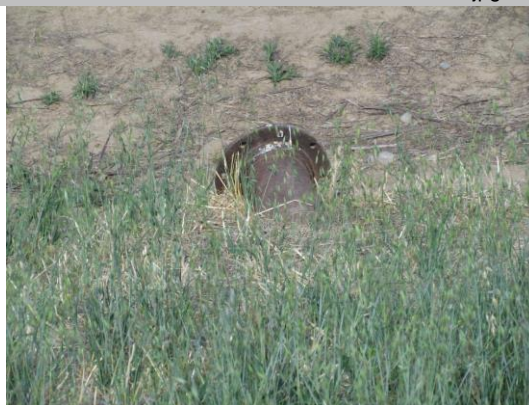
Photo 2 of 3 : UCIP_SP_2019_53068_75108.jpg

Pipe open on LS end. Photo courtesy of Sterling York, DWR Inspector.

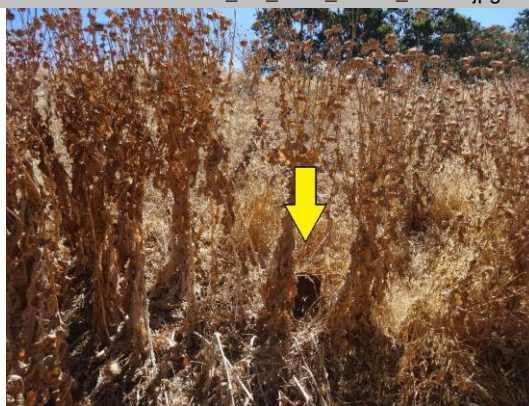
Photo 3 of 3 : UCIP_SP_2019_53068_76120.jpg

Comment Code						
Inspector Comment						
FS_ID:53068 DS_ID:17917 EP_NO: N/A Repair Type: Non-Urgent Crossing Status: Not Found UCIP Comments: 10/15/2018 Pipe not found. Pipe removed as part of the Project Area A Feather River West Levee Project. Contacted LMA to obtain as-built drawings showing the pipe removal through the levee. Crossing has been downgraded from Urgent to Non-Urgent, waiting to receive as-built drawings pertaining to levee improvement project for this section of the levee. (O. Magana - DWR UCIP)07/20/2016 Same as previous comment, although pipe is open on the waterside (WS) and capped on the LS. Note that this section of levee will likely be reconstructed as part of Project Area A of the Feather River West Levee Project (Star Bend to Sutter Bypass). (K. Fazel - UCIP)05/23/2016 Needs proper abandonment; pipe open on both ends (courtesy of Sterling York, DWR Inspector). (K. Fazel - UCIP) FIELD_STRUCT_DESC: *REMOVED* 8-inch steel pipe of an unknown purpose through the levee, 4.6 feet below the crown. Siphon breaker in a 24-inch corrugated metal pipe (CMP) riser on the landside (LS) shoulder, not found in 2016. [Additional Reference(s): DWR Levee Log, 2005. USACE Sacramento O&M Manual 144, August 1955, (Station 657+00), As-Built Drawing No. 4-4-205-1]. FS Date: 10/16/2018

LS view: pipe appears to be capped, though in a rudimentary fashion.

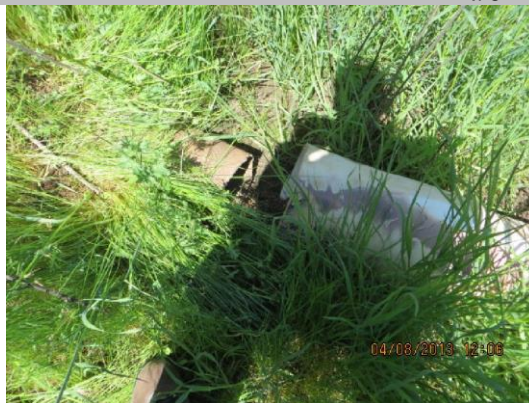
Photo 1 of 3 : UCIP_SP_2019_11383_18782.jpg

LM Start	2.21	Rating **	M	Issue No.	29	
LM End	2.21	Issue Type +	En	Location *		
Category	Supplemental			GPS Latitude/Longitude		
				Start		End
Item	DWR UCIP Field Study			38.982135 °		38.982135 °
				-121.591974 °		-121.591974 °
DWR ID	17915					
Comment Code						
Inspector Comment						
FS_ID:11383 DS_ID:17915 EP_NO: N/A Repair Type: Non-Urgent Crossing Status: Found UCIP Comments: 04/12/2013 Siphon breaker cap missing. Sump pump and gate valve at landward toe not found may be due to dense vegetation. (DWR UCIP - P. Amatya) FIELD_STRUCT_DESC: 8-inch coated steel pipe of an unknown purpose through the levee, 4.6 feet below the crown. Siphon breaker in a corrugated metal pipe (CMP) riser on the landside (LS) slope. [Additional Reference(s): DWR Levee Log, 2005. USACE Sacramento O&M Manual 144, August 1955, (Station 638+07)]. FS Date: 4/12/2013

WS- 8-inch steel pipe and disconnected pvc pipe on levee slope

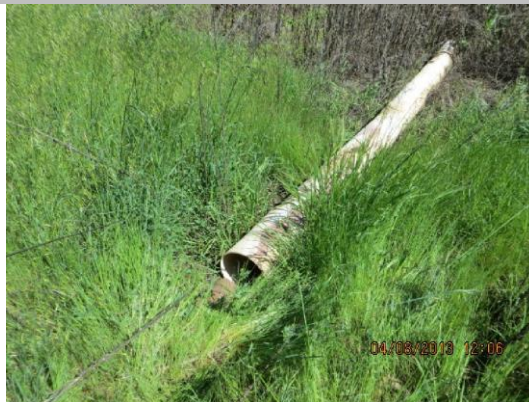
Photo 2 of 3 : UCIP_SP_2019_11383_18781.jpg

WS-a disconnected pvc pipe on levee slope

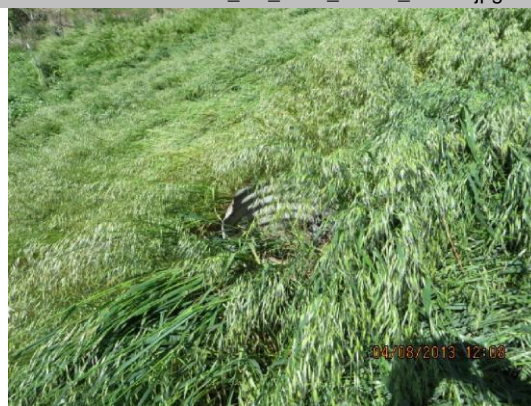
Photo 3 of 3 : UCIP_SP_2019_11383_18780.jpg

LM Start	2.21	Rating **	M	Issue No.	29 (cont)	
LM End	2.21	Issue Type +	En	Location *		
Category	Supplemental			GPS Latitude/Longitude		
				Start		End
Item	DWR UCIP Field Study			38.982135 °		38.982135 °
				-121.591974 °		-121.591974 °
DWR ID	17915					
Comment Code						
Inspector Comment						
FS_ID:11383 DS_ID:17915 EP_NO: N/A Repair Type: Non-Urgent Crossing Status: Found UCIP Comments: 04/12/2013 Siphon breaker cap missing. Sump pump and gate valve at landward toe not found may be due to dense vegetation. (DWR UCIP - P. Amatya) FIELD_STRUCT_DESC: 8-inch coated steel pipe of an unknown purpose through the levee, 4.6 feet below the crown. Siphon breaker in a corrugated metal pipe (CMP) riser on the landside (LS) slope. [Additional Reference(s): DWR Levee Log, 2005. USACE Sacramento O&M Manual 144, August 1955, (Station 638+07)]. FS Date: 4/12/2013

LS- CMP riser on levee slope with dense vegetation.

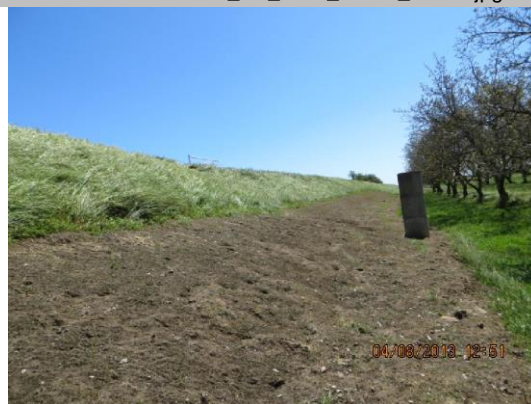
Photo 1 of 3 : UCIP_SP_2019_41787_18793.jpg

Comment Code					
Inspector Comment					
FS_ID:41787 DS_ID:18667 EP_NO: N/A Repair Type: Non-Urgent Crossing Status: Found UCIP Comments: 04/12/2013 Pipe appears to be abandoned and should be verified as having been done so properly. - concrete standpipe with 10-inch steel pipe.- concrete wing wall- no pipe- abandoned structure- a pump found on other side of the levee (WS) but not sure whether it is associated with this crossing. (DWR UCIP - P. Amatya) FIELD_STRUCT_DESC: *ABANDONED* 24-inch gravity drainage pipe of an unknown material under the landside (LS) approach, at an unknown depth. Plans to install a 10-inch corrugated iron gravity drainage culvert under the LS approach, at an unknown depth. Crossing not found in the O&M Manual. FS Date: 4/12/2013

LS- overview of landside with concrete standpipe

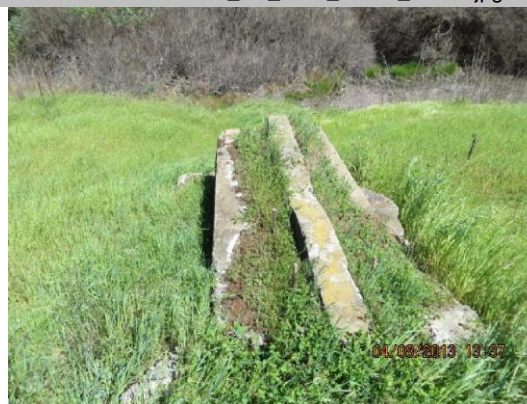
Photo 1 of 3 : UCIP_SP_2019_41348_18882.jpg

Comment Code					
Inspector Comment					
FS_ID:41348					
DS_ID:17918					
EP_NO: N/A					
Repair Type: Non-Urgent					
Crossing Status: Indicator Found					
UCIP Comments: 04/08/2013 Only an abandoned steel structure on water and a concrete structure on WS Levee slope found. Need to verify pipe was properly abandoned. (DWR UCIP - P. Amatya)					
FIELD_STRUCT_DESC: *ABANDONED* 8-inch steel pipe of an unknown purpose through the levee, 4.1 feet below the crown. Siphon breaker on the landside (LS) slope. Butterfly shutoff valve on the LS slope. Concrete standpipe and pump at the LS toe. Pipe discharges into borrow pit on the waterside (WS). [Additional Reference(s): DWR Levee Log, 2005. USACE Sacramento O&M Manual 144, August 1955, (Station 574+20)].					
FS Date: 4/8/2013

WS- abandoned concrete structure on levee slope

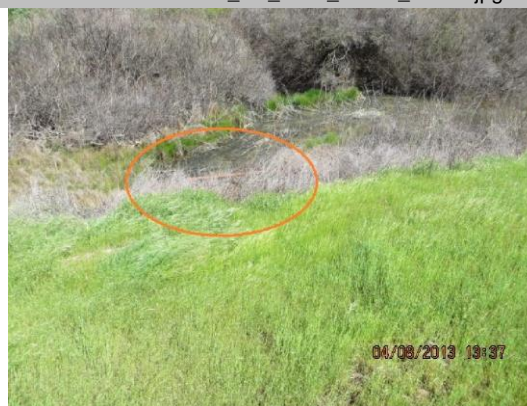
Photo 2 of 3 : UCIP_SP_2019_41348_18881.jpg

Comment Code						
Inspector Comment						
FS_ID:41348 DS_ID:17918 EP_NO: N/A Repair Type: Non-Urgent Crossing Status: Indicator Found UCIP Comments: 04/08/2013 Only an abandoned steel structure on water and a concrete structure on WS Levee slope found. Need to verify pipe was properly abandoned. (DWR UCIP - P. Amatya) FIELD_STRUCT_DESC: *ABANDONED* 8-inch steel pipe of an unknown purpose through the levee, 4.1 feet below the crown. Siphon breaker on the landside (LS) slope. Butterfly shutoff valve on the LS slope. Concrete standpipe and pump at the LS toe. Pipe discharges into borrow pit on the waterside (WS). [Additional Reference(s): DWR Levee Log, 2005. USACE Sacramento O&M Manual 144, August 1955, (Station 574+20)]. FS Date: 4/8/2013

WS- abandoned steel structure on waterway

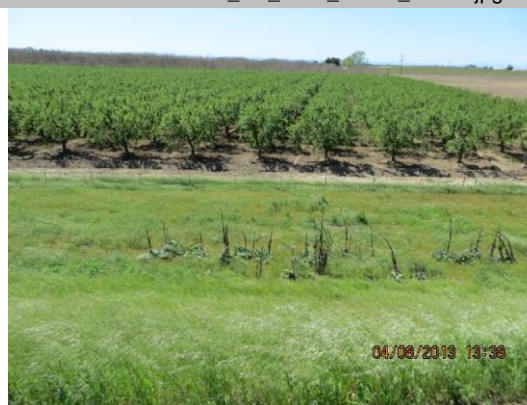
Photo 3 of 3 : UCIP_SP_2019_41348_18880.jpg

Overview of landside of the levee- no pipes visible. Dense vegetation.

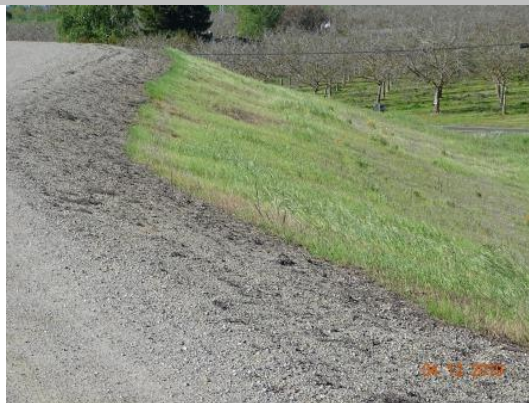
Photo 1 of 1 : SP_2019_LD0001S_433_15_20190415_00045.jpg

View looking downstream landside at the well maintained annual vegetation, Spring 2019.

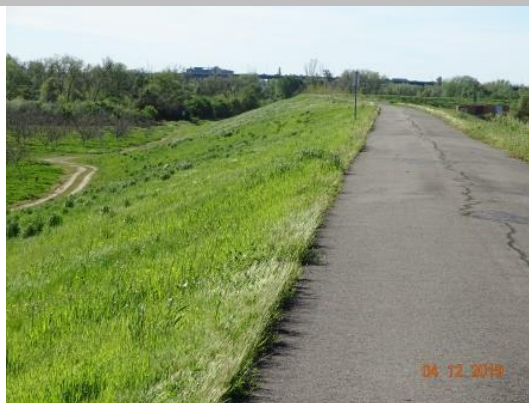
Photo 1 of 1 : SP_2019_LD0001S_433_16_20190415_00046.jpg

LM Start	3.72	Rating **	A	Issue No.	16
LM End	16.10	Issue Type +	Ma	Location *	WS
Category	Earthen Levee			GPS Latitude/Longitude	
				Start	End
Item	Vegetation			39.003134 °	39.168732 °
				-121.596628 °	-121.622687 °
DWR ID	DWR_LD0001S_01_s_2019_16				
Comment Code					
V1 : Control annual grass and weeds on the levee slopes and easements.					
Inspector Comment					
The annual vegetation is well maintained through this section of levee, Spring 2019.

View looking downstream waterside at the well maintained annual vegetation, Spring 2019.

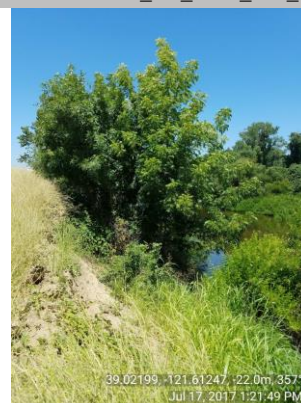
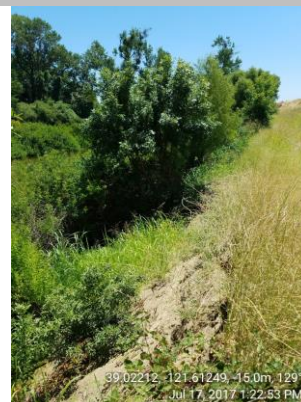
LM Start	5.02	Rating **	A/W	Issue No.	25	
LM End	5.02	Issue Type +	Ma	Location *		
Category	Supplemental			GPS Latitude/Longitude		
				Start		End
Item	2017 Storm Damage			39.018322 °	39.018322 °	
				-121.610275 °	-121.610275 °	
DWR ID	DWR_LD0001S_01_f_2017_25					
Comment Code						
Inspector Comment						
Levee Evaluation Comments						
Description:						
Site ID No:145						
Site Designation:LD1-S-02						
Repair Type: Erosion						
Rating:Critical						
Field Date:7/17/2017						
Notes:

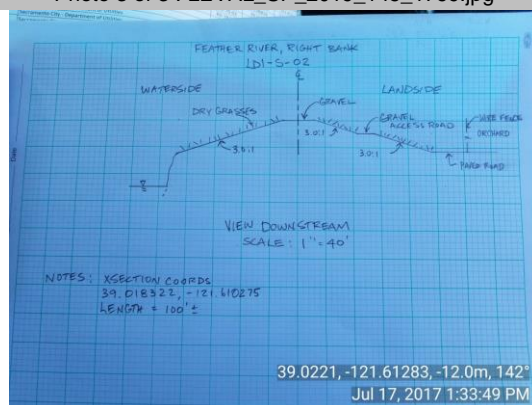
Photo 3 of 3 : LEVAL_SP_2019_145_1769.jpg

LM Start	5.02	Rating **	A/W	Issue No.	25 (cont)	
LM End	5.02	Issue Type +	Ma	Location *		
Category	Supplemental			GPS Latitude/Longitude		
				Start		End
Item	2017 Storm Damage			39.018322 °	39.018322 °	
				-121.610275 °	-121.610275 °	
DWR ID	DWR_LD0001S_01_f_2017_25					
Comment Code						
Inspector Comment						
Levee Evaluation Comments						
Description:						
Site ID No:145						
Site Designation:LD1-S-02						
Repair Type: Erosion						
Rating:Critical						
Field Date:7/17/2017						
Notes:

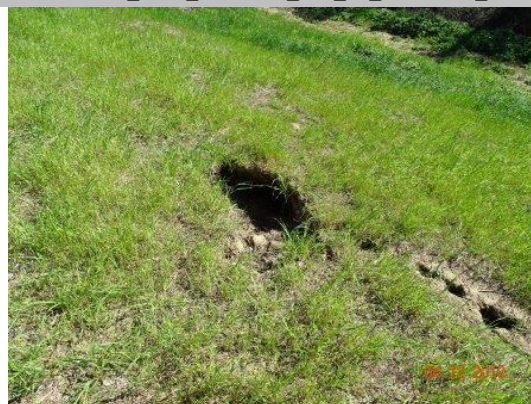
Photo 1 of 1 : SP_2019_LD0001S_433_18_20190415_00044.jpg

LM Start	5.65	Rating **	U	Issue No.	18
LM End	5.65	Issue Type +	Ma	Location *	WS
Category	Earthen Levee			GPS Latitude/Longitude	
				Start	End
Item	Animal Control			39.026940 °	39.026940 °
				-121.613100 °	-121.613100 °
DWR ID	DWR_LD0001S_01_s_2019_18				
Comment Code					
A3 : No rodents visible, but rodent burrows visible; need to backfill and compact or grout burrows.					
Inspector Comment					
Repair rodent hole in levee slope, Spring 2019.

View looking at waterside levee slope of a large rodent/animal hole, Spring 2019.

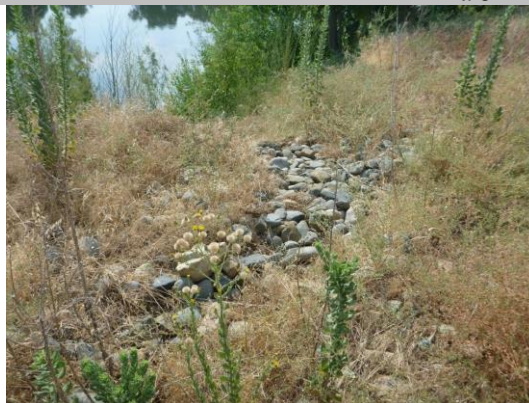
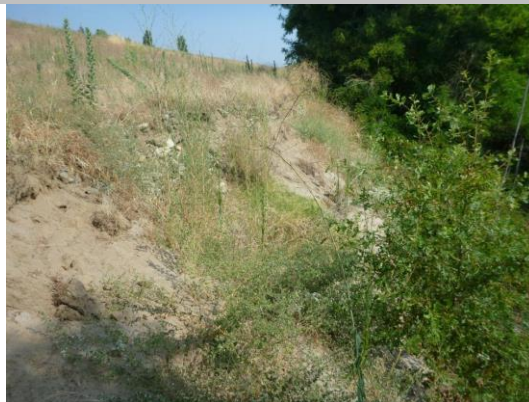
LM Start	7.69	Rating **	A/W	Issue No.	19	
LM End	7.74	Issue Type +	Ma	Location *		
Category	Supplemental			GPS Latitude/Longitude		
				Start	End	
Item	2017 Storm Damage			39.055986 °	39.056710 °	
				-121.611301 °	-121.611331 °	
DWR ID	DWR_LD0001S_01_f_2017_19					
Comment Code						
Inspector Comment						
Levee Evaluation Comments						
Description:						
Site ID No:146						
Site Designation:LD1-S-03						
Repair Type: Erosion						
Rating:Area of Concern						
Field Date:8/3/2017						
Notes:

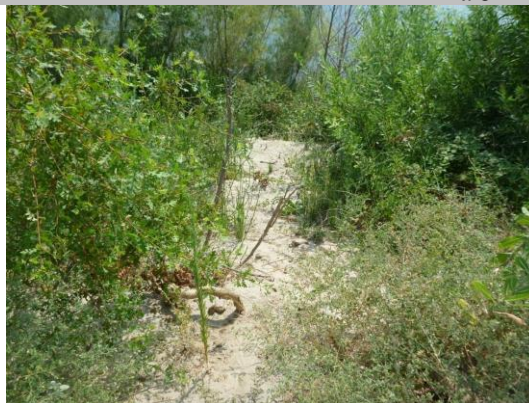
Photo 3 of 3 : LEVAL_SP_2019_146_4054.jpg

LM Start	7.69	Rating **	A/W	Issue No.	19 (cont)	
LM End	7.74	Issue Type +	Ma	Location *		
Category	Supplemental			GPS Latitude/Longitude		
				Start	End	
Item	2017 Storm Damage			39.055986 °	39.056710 °	
				-121.611301 °	-121.611331 °	
DWR ID	DWR_LD0001S_01_f_2017_19					
Comment Code						
Inspector Comment						
Levee Evaluation Comments						
Description:						
Site ID No:146						
Site Designation:LD1-S-03						
Repair Type: Erosion						
Rating:Area of Concern						
Field Date:8/3/2017						
Notes:

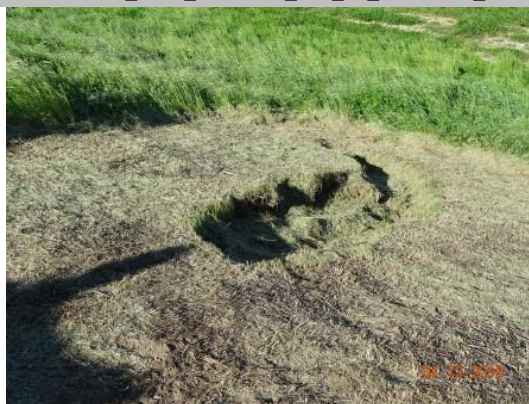
Photo 1 of 1 : SP_2019_LD0001S_433_17_20190415_00043.jpg

LM Start	8.55	Rating **	M	Issue No.	17
LM End	8.55	Issue Type +	Ma	Location *	LS
Category	Earthen Levee			GPS Latitude/Longitude	
				Start	End
Item	Animal Control			39.067929 °	39.067929 °
				-121.608064 °	-121.608064 °
DWR ID	DWR_LD0001S_01_s_2019_17				
Comment Code					
A3 : No rodents visible, but rodent burrows visible; need to backfill and compact or grout burrows.					
Inspector Comment					
There are large depressions in the levee slope that appear to be caused by some type of burrowing animals that needs to be repaired, Spring 2019.

View looking at the landside levee slope at large depressions in the levee that appear to be caused by some type of burrowing animals that need to be repaired, Spring 2019.

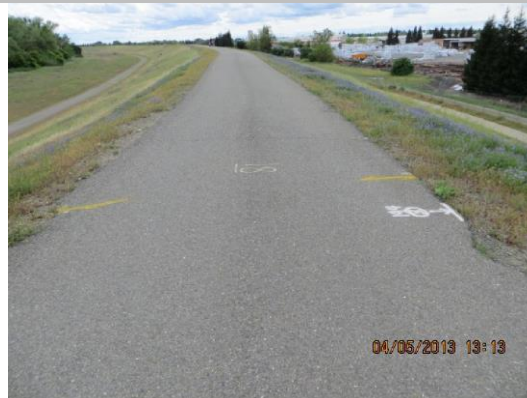
Photo 1 of 3 : UCIP_SP_2019_41841_19538.jpg

LM Start	11.99	Rating **	M	Issue No.	32
LM End	11.99	Issue Type +	En	Location *	
Category	Supplemental			GPS Latitude/Longitude	
				Start	End
Item	DWR UCIP Field Study			39.114856 °	39.114856 °
				-121.605821 °	-121.605821 °
DWR ID	17932				
Comment Code					
Inspector Comment					
FS_ID:41841 DS_ID:17932 EP_NO: N/A Repair Type: Non-Urgent Crossing Status: Indicator Found UCIP Comments: 04/05/2013 Need to install Gasline Markers.Fenced control station.Indicator on LS across concrete ditch.Found road markings.(DWR UCIP - P. Amatya) FIELD_STRUCT_DESC: 1 of 2: 16-inch natural gas pipeline of an unknown material through the levee, 3 feet below the crown. PG&E gas line crossing sign on the waterside (WS) shoulder. [Additional Reference(s): DWR Levee Log, 2005]. FS Date: 4/5/2013

Levee Crown: gasoline indicator/markings on crown road.

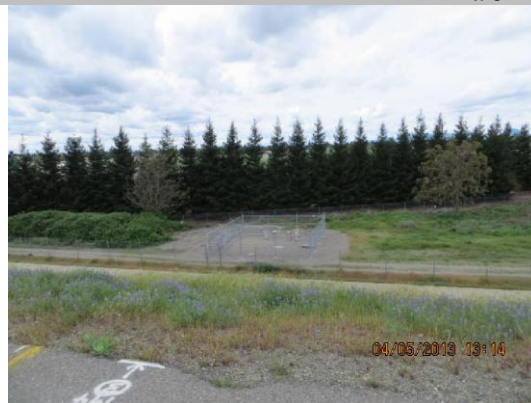
Photo 2 of 3 : UCIP_SP_2019_41841_19537.jpg

LM Start	11.99	Rating **	M	Issue No.	32 (cont)	
LM End	11.99	Issue Type +	En	Location *		
Category	Supplemental			GPS Latitude/Longitude		
				Start	End	
Item	DWR UCIP Field Study			39.114856 °	39.114856 °	
				-121.605821 °	-121.605821 °	
DWR ID	17932					
Comment Code						
Inspector Comment						
FS_ID:41841 DS_ID:17932 EP_NO: N/A Repair Type: Non-Urgent Crossing Status: Indicator Found UCIP Comments: 04/05/2013 Need to install Gasline Markers.Fenced control station.Indicator on LS across concrete ditch.Found road markings.(DWR UCIP - P. Amatya) FIELD_STRUCT_DESC: 1 of 2: 16-inch natural gas pipeline of an unknown material through the levee, 3 feet below the crown. PG&E gas line crossing sign on the waterside (WS) shoulder. [Additional Reference(s): DWR Levee Log, 2005]. FS Date: 4/5/2013

LS- fenced control station across concrete ditch

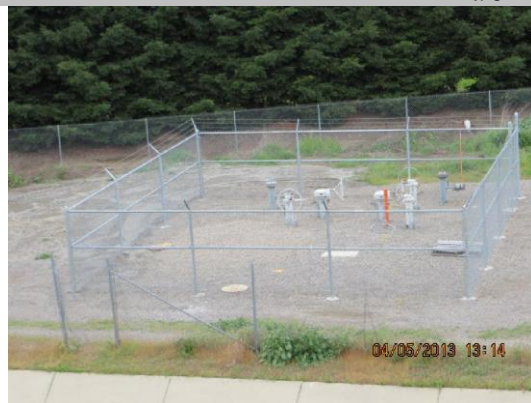
Photo 3 of 3 : UCIP_SP_2019_41841_19534.jpg

LS- fenced control station with indicators

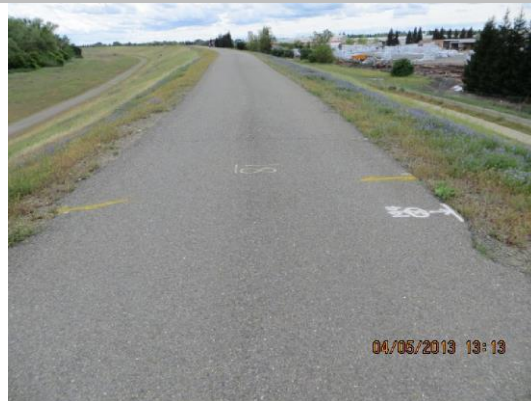
Photo 1 of 3 : UCIP_SP_2019_41889_19566.jpg

LM Start	12.00	Rating **	M	Issue No.	33
LM End	12.00	Issue Type +	En	Location *	
Category	Supplemental			GPS Latitude/Longitude	
				Start	End
Item	DWR UCIP Field Study			39.114856 °	39.114856 °
				-121.605821 °	-121.605821 °
DWR ID	18880				
Comment Code					
Inspector Comment					
FS_ID:41889 DS_ID:18880 EP_NO: N/A Repair Type: Non-Urgent Crossing Status: Indicator Found UCIP Comments: 04/05/2013 Need to contact owner to install gasoline markers.Fenced control station on LS.Indicator on LS across concrete channel.Road markings. (DWR UCIP - P. Amatya) FIELD_STRUCT_DESC: 2 of 2: 16-inch natural gas pipeline of an unknown material through the levee, 3 feet below the crown. PG&E gas line crossing sign on the waterside (WS) shoulder. [Additional Reference(s): DWR Levee Log, 2005]. FS Date: 4/5/2013

Levee Crown: road markings on road pavement

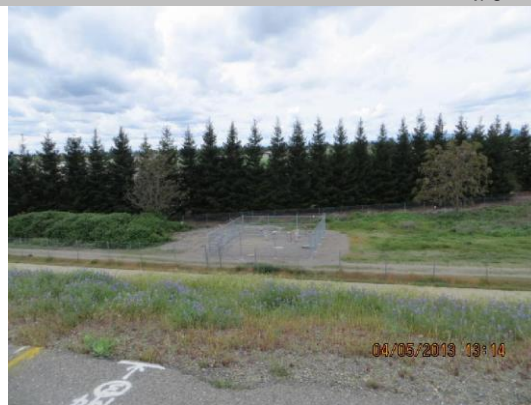
Photo 2 of 3 : UCIP_SP_2019_41889_19565.jpg

LS- fenced control station across concrete ditch.

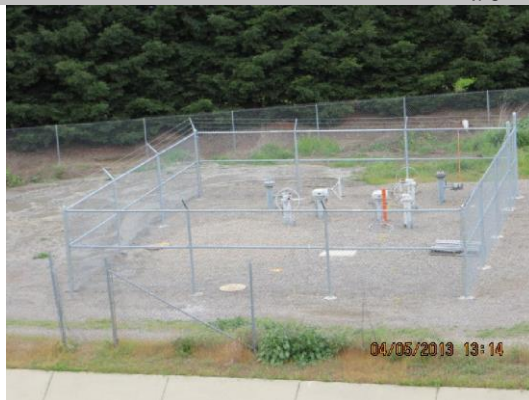
Photo 3 of 3 : UCIP_SP_2019_41889_19564.jpg

LM Start	12.00	Rating **	M	Issue No.	33 (cont)	
LM End	12.00	Issue Type +	En	Location *		
Category	Supplemental			GPS Latitude/Longitude		
				Start	End	
Item	DWR UCIP Field Study			39.114856 °	39.114856 °	
				-121.605821 °	-121.605821 °	
DWR ID	18880					
Comment Code						
Inspector Comment						
FS_ID:41889 DS_ID:18880 EP_NO: N/A Repair Type: Non-Urgent Crossing Status: Indicator Found UCIP Comments: 04/05/2013 Need to contact owner to install gasoline markers.Fenced control station on LS.Indicator on LS across concrete channel.Road markings. (DWR UCIP - P. Amaty) FIELD_STRUCT_DESC: 2 of 2: 16-inch natural gas pipeline of an unknown material through the levee, 3 feet below the crown. PG&E gas line crossing sign on the waterside (WS) shoulder. [Additional Reference(s): DWR Levee Log, 2005]. FS Date: 4/5/2013

LS- fenced control station with gasoline indicator across concrete ditch.

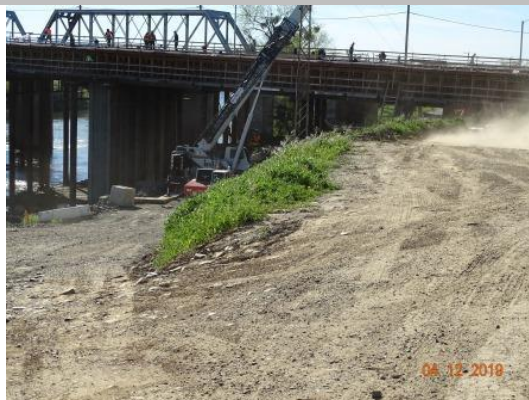
Photo 1 of 2 : SP_2019_LD0001S_433_26_20190415_00047.jpg

LM Start	13.87	Rating **	A/W	Issue No.	26
LM End	13.87	Issue Type +	Ma	Location *	CR
Category	Earthen Levee			GPS Latitude/Longitude	
				Start	End
Item	Crown Surface / Depressions / Rutting			39.139734 °	39.139734 °
				-121.608477 °	-121.608477 °
DWR ID	DWR_LD0001S_01_f _ 2018_26				
Comment Code					
C2 : Repair depressions or ruts in the crown or slope.					
Inspector Comment					
There is ongoing construction at the 5th Street Bridge, Fall 2018.

View looking downstream waterside of the 5th Street bridge construction, Spring 2019.

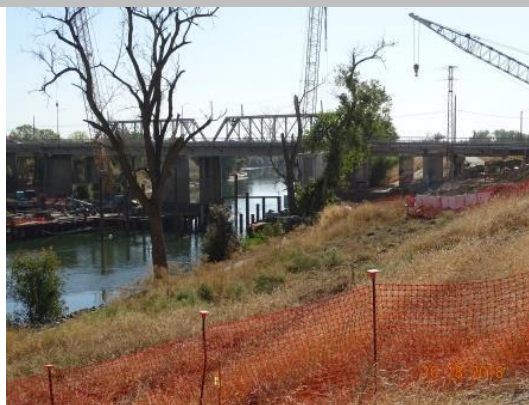
Photo 2 of 2 : SP_2019_LD0001S_433_26_20190305_00011.jpg

View looking downstream waterside of the 5th Street bridge construction, Fall 2018.

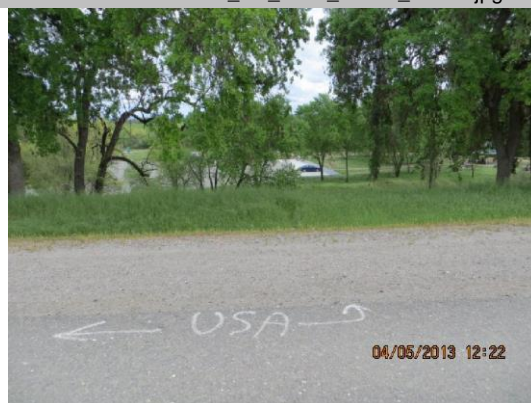
Photo 1 of 3 : UCIP_SP_2019_41887_19571.jpg

LM Start	14.35	Rating **	M	Issue No.	34
LM End	14.35	Issue Type +	En	Location *	
Category	Supplemental			GPS Latitude/Longitude	
				Start	End
Item	DWR UCIP Field Study			39.146494 °	39.146494 °
				-121.609715 °	-121.609715 °
DWR ID	18640				
Comment Code					
Inspector Comment					
FS_ID:41887 DS_ID:18640 EP_NO: N/A Repair Type: Non-Urgent Crossing Status: Indicator Found UCIP Comments: 04/05/2013 Need to contact ownder to determin status of crossing and install signs if appropriate. (DWR UCIP - P. Amatya) FIELD_STRUCT_DESC: 18-inch steel natural gas pipeline through the levee, at an unknown depth. [Additional Reference(s): Sutter-Butte Flood Control Agency, Volume 3, As-Built Drawing No. GC-120, Sheet 58, no reference to any crossings at this location. USACE Sacramento O&M Manual 144, August 1955, (Station 1473+60)]. FS Date: 4/5/2013

WS- USA road marking and floodway area

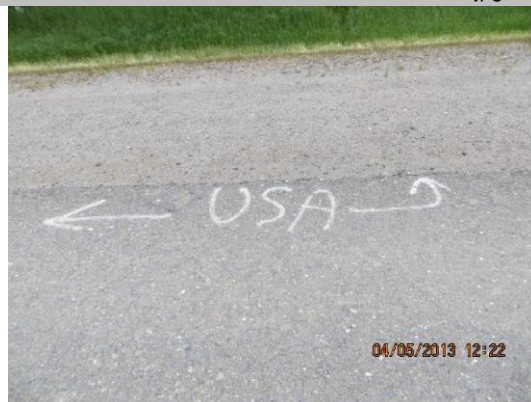
Photo 2 of 3 : UCIP_SP_2019_41887_19570.jpg

WS- USA road marking on pavement

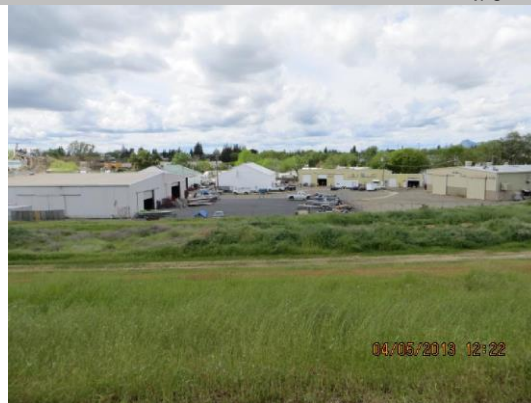
Photo 3 of 3 : UCIP_SP_2019_41887_19569.jpg

LM Start	14.35	Rating **	M	Issue No.	34 (cont)	
LM End	14.35	Issue Type +	En	Location *		
Category	Supplemental			GPS Latitude/Longitude		
				Start		End
Item	DWR UCIP Field Study			39.146494 °		39.146494 °
				-121.609715 °		-121.609715 °
DWR ID	18640					
Comment Code						
Inspector Comment						
FS_ID:41887 DS_ID:18640 EP_NO: N/A Repair Type: Non-Urgent Crossing Status: Indicator Found UCIP Comments: 04/05/2013 Need to contact ownder to determin status of crossing and install signs if appropriate. (DWR UCIP - P. Amatya) FIELD_STRUCT_DESC: 18-inch steel natural gas pipeline through the levee, at an unknown depth. [Additional Reference(s): Sutter-Butte Flood Control Agency, Volume 3, As-Built Drawing No. GC-120, Sheet 58, no reference to any crossings at this location. USACE Sacramento O&M Manual 144, August 1955, (Station 1473+60)]. FS Date: 4/5/2013

LS- overview. No sign post or indicator found.

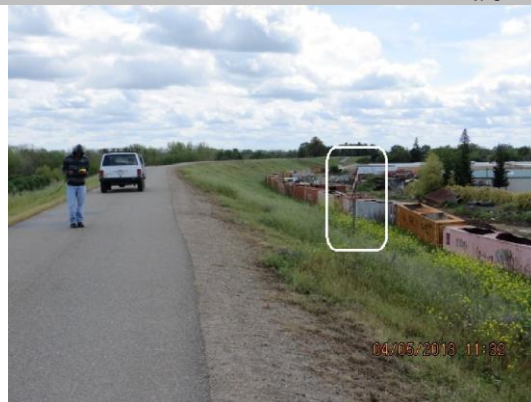
Photo 1 of 2 : UCIP_SP_2019_12092_19624.jpg

Comment Code					
Inspector Comment					
FS_ID:12092 DS_ID:17923 EP_NO: N/A Repair Type: Non-Urgent Crossing Status: Indicator Found UCIP Comments: 04/05/2013 Only a gasoline indicator found on LS.Needs gasoline marker also on WS.(DWR UCIP - P. Amatya) FIELD_STRUCT_DESC: 16-inch natural gas pipeline of an unknown material through the levee, 3.5 feet below the crown. Pipeline protected in place as part of the Feather River West Levee Reconstruction Project. Marker installed on the landside (LS). [Additional Reference(s): DWR Levee Log, 2005. Sutter-Butte Flood Control Agency, Volume 3, As-Built Drawing No. C-124, Sheet 62, (Station 1073+41)]. FS Date: 4/5/2013

LS- overview of gasoline marker on levee slope

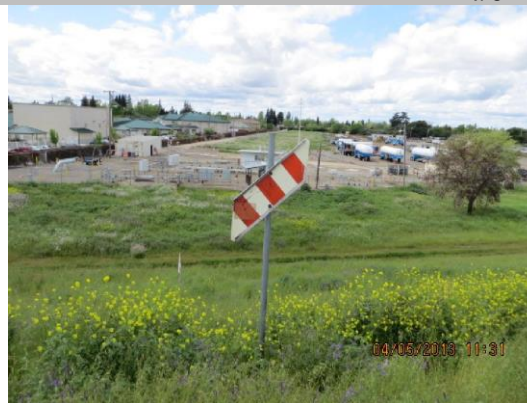
Photo 2 of 2 : UCIP_SP_2019_12092_19623.jpg

Comment Code						
Inspector Comment						
FS_ID:12092 DS_ID:17923 EP_NO: N/A Repair Type: Non-Urgent Crossing Status: Indicator Found UCIP Comments: 04/05/2013 Only a gasoline indicator found on LS.Needs gasoline marker also on WS.(DWR UCIP - P. Amatya) FIELD_STRUCT_DESC: 16-inch natural gas pipeline of an unknown material through the levee, 3.5 feet below the crown. Pipeline protected in place as part of the Feather River West Levee Reconstruction Project. Marker installed on the landside (LS). [Additional Reference(s): DWR Levee Log, 2005. Sutter-Butte Flood Control Agency, Volume 3, As-Built Drawing No. C-124, Sheet 62, (Station 1073+41)]. FS Date: 4/5/2013

LS- gasoline marker on levee slope

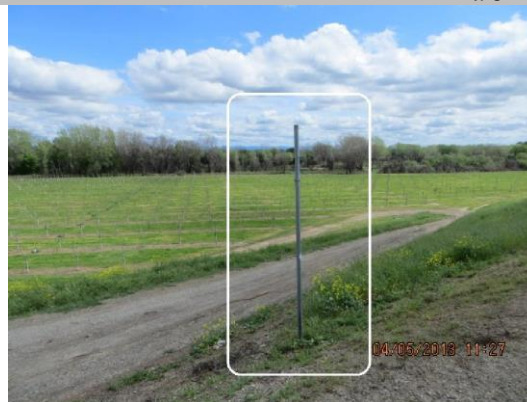
Photo 1 of 3 : UCIP_SP_2019_12104_19642.jpg

Comment Code					
Inspector Comment					
FS_ID:12104 DS_ID:18644 EP_NO: 17259 Repair Type: Non-Urgent Crossing Status: Indicator Found UCIP Comments: 04/05/2013 Found an indicator only on LS. Needs an indicator also on WS.(DWR UCIP - P. Amatya) FIELD_STRUCT_DESC: *REMOVED* 8.375-inch-wide electrolysis test station (ETS) at a depth of 4 feet was connected to the existing 8-inch steel natural gas pipeline within the waterside (WS) levee toe. Pipeline has been removed as part of the Feather River West Levee Reconstruction Project. [Additional Reference(s): Sutter-Butte Flood Control Agency, Volume 3, As-Built Drawing No. C-124, Sheet 62, (Station 1079+91), no replacement pipe mentioned]. FS Date: 4/5/2013

WS- needs a gasoline indicator.

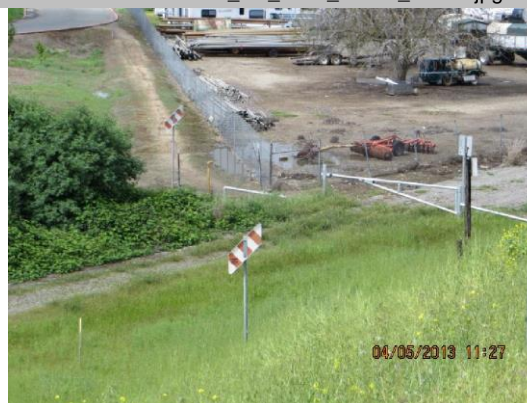
Photo 2 of 3 : UCIP_SP_2019_12104_19641.jpg

Comment Code						
Inspector Comment						
FS_ID:12104 DS_ID:18644 EP_NO: 17259 Repair Type: Non-Urgent Crossing Status: Indicator Found UCIP Comments: 04/05/2013 Found an indicator only on LS. Needs an indicator also on WS.(DWR UCIP - P. Amatya) FIELD_STRUCT_DESC: *REMOVED* 8.375-inch-wide electrolysis test station (ETS) at a depth of 4 feet was connected to the existing 8-inch steel natural gas pipeline within the waterside (WS) levee toe. Pipeline has been removed as part of the Feather River West Levee Reconstruction Project. [Additional Reference(s): Sutter-Butte Flood Control Agency, Volume 3, As-Built Drawing No. C-124, Sheet 62, (Station 1079+91), no replacement pipe mentioned]. FS Date: 4/5/2013

LS- gasline indicators on levee slope and across.

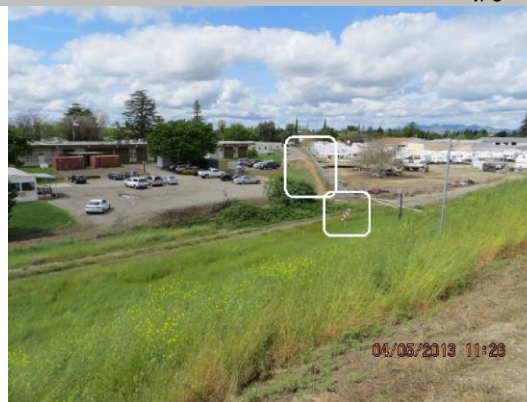
Photo 3 of 3 : UCIP_SP_2019_12104_19640.jpg

LS- overview of gasline indicators on levee slope and across.

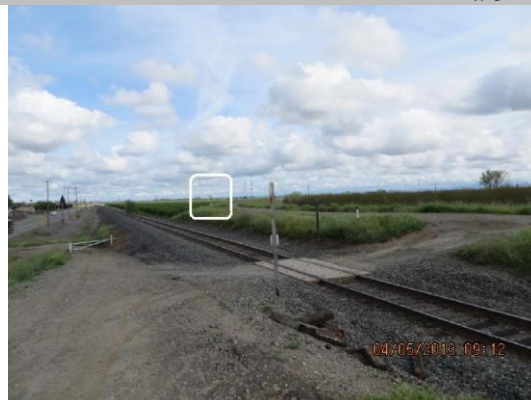
Photo 1 of 2 : UCIP_SP_2019_41888_19709.jpg

Railway and levee crossing and gasline sign across the railway

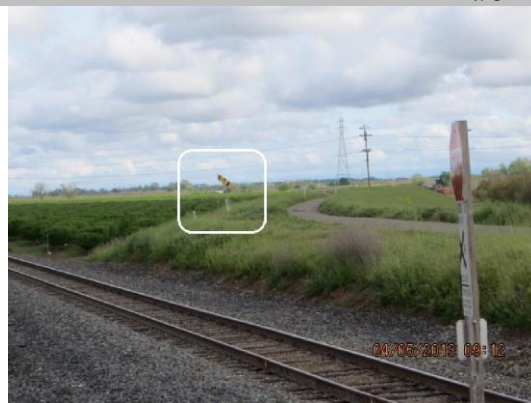
Photo 2 of 2 : UCIP_SP_2019_41888_19708.jpg

Gasline sign across the railway
